MY XXXXXXXXX

Official Number: XXXX Commerical Yacht Grt: 498 LOA: XXXX , Beam XXXX m,
Registry : XXXXXXXXXXXX .Call sign : XXXXX , BHP : 2816

WEEKLY REFIT REPORT

Period 2nd, Monday Febuary 2009 ----- 6th , Friday, February, 2009

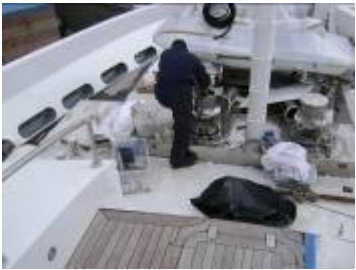
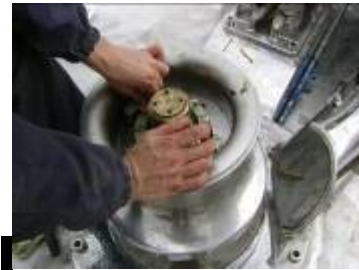
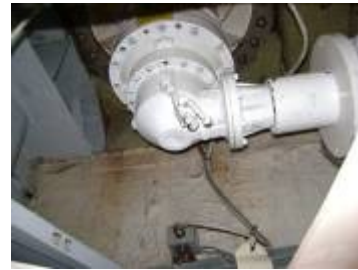
1. Rebuilding port side windlass and pipe work prep*

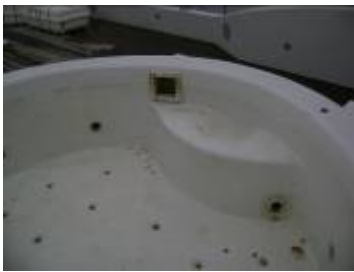
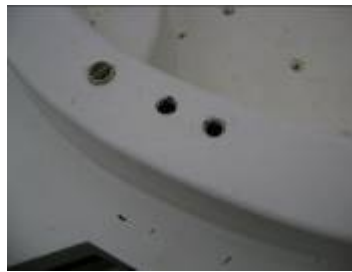
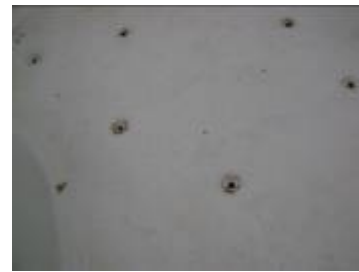
2. Stripped Jacuzzi parts*

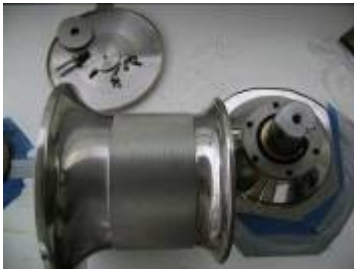
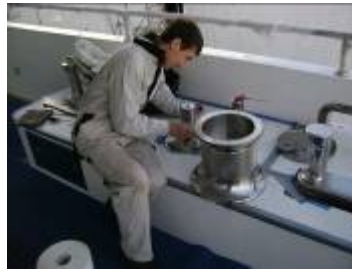
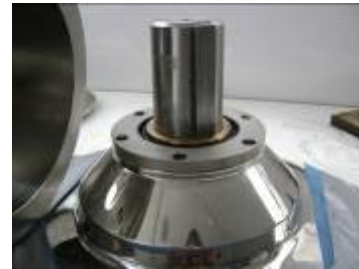
3. Stripped and cleaned aft capstans*

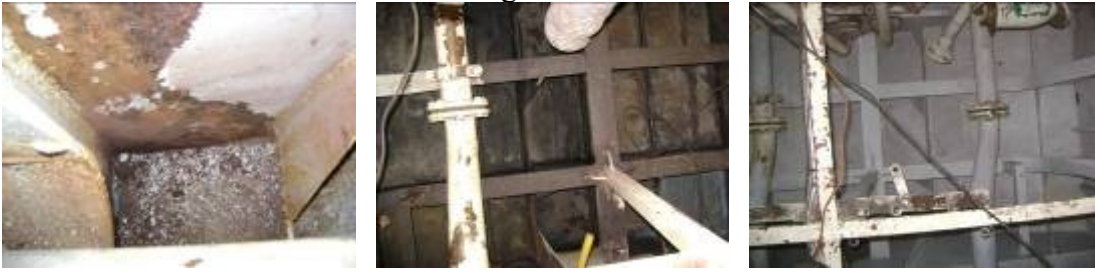
1. Engine room Rust removal, Ferox*

All crew work progressing well and quality of work up to a good standard. Bilge work concentrating on what needs to be done this year as the entire internally steel surfaces of the vessel where NOT primed which has lead to rust on all surfaces under the paint. Time will have to be allocated over the nest 2 work periods to rectify the entire problem.

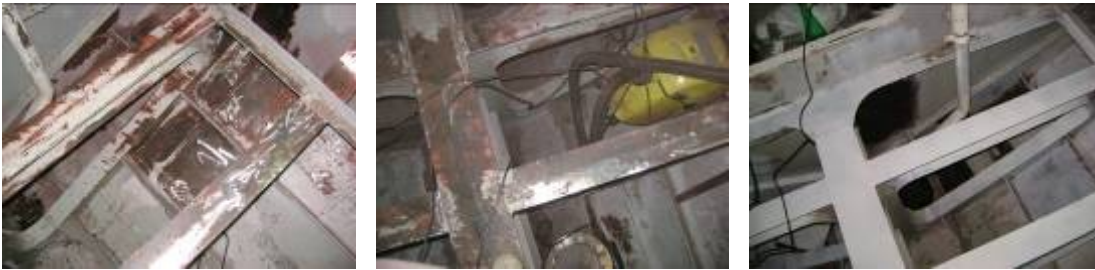
2. Boiler room Bilge additional rust removal and priming*

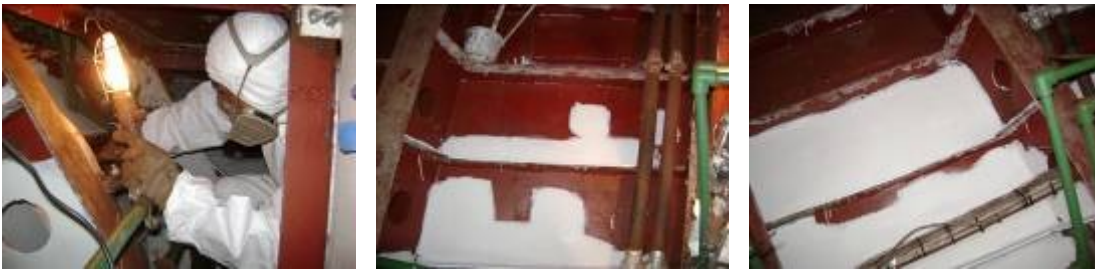
3. Preparation for Crew mess and tank top first coat Danboline*

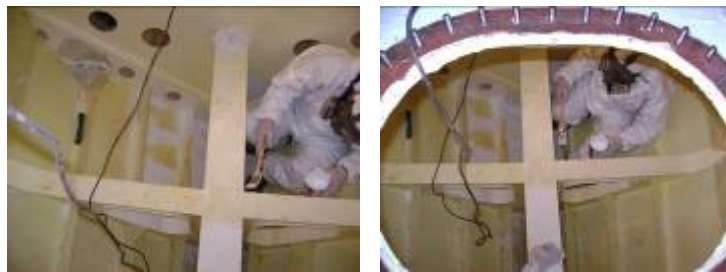
4. Final coat fwd water tank*

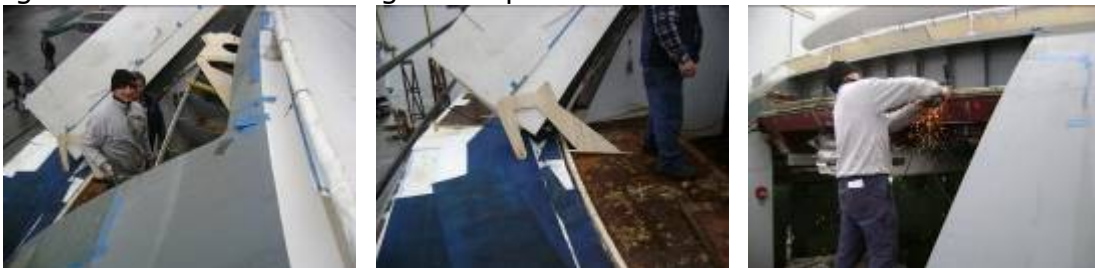
1. Cutting Section of aft for fitting of templates for aft door*

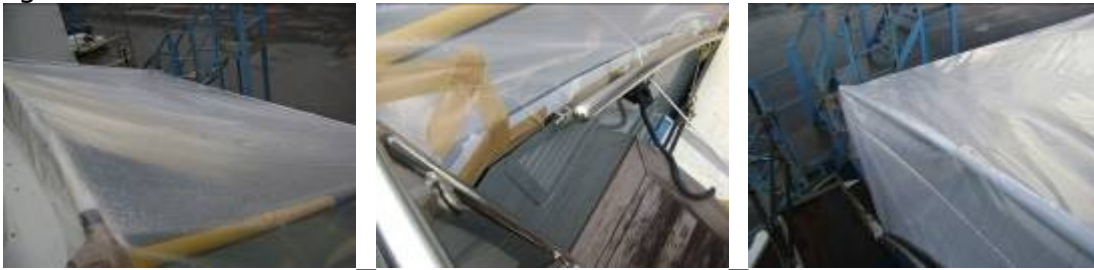
2. Tenting the aft door*

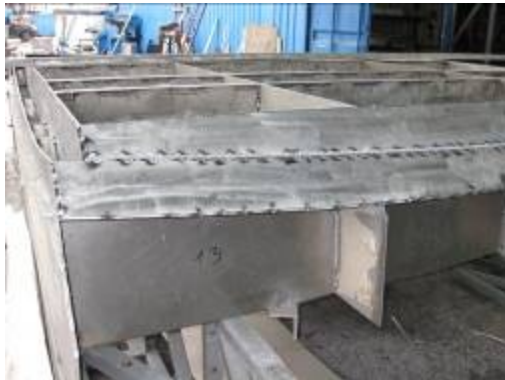
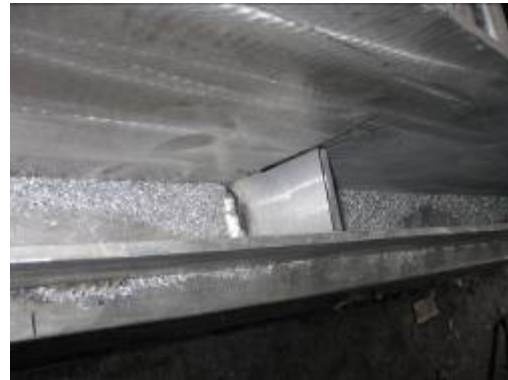
**Stern Door Construction inspection**

A site visit was arranged for inspection of the construction of the stern door. Welding and construction method of door and the manufacturing of hatch covers to be installed in the garage area where inspected. Welding was inspected for penetration depth and quality and found to be of good quality workmanship. Computer direct cutting (CDC) milling of the hatches to be installed was completed to a good standard and materials used where of good quality.
